Manhole Inspection Summary

Manhole # S33II1025MH

Location Address: **4 MILLNROOK RD**

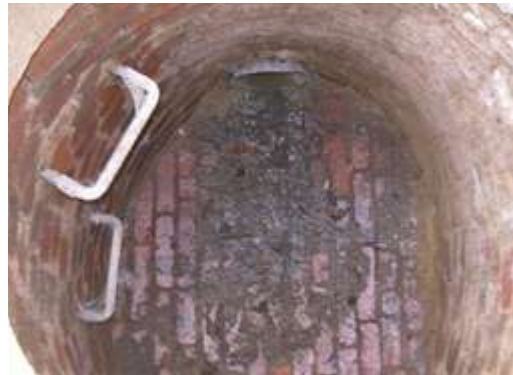
Top View

Channel debris.

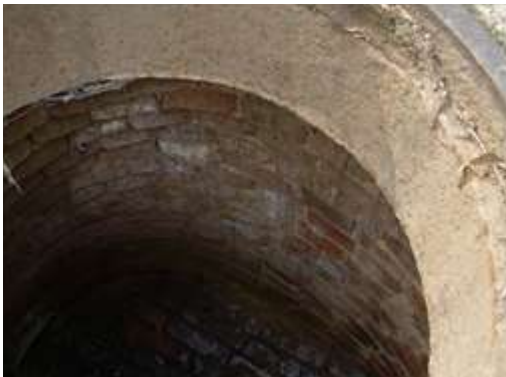
Defect

☒ **Leaks**

Infiltration: ☐ None ☒ **Joint** ☐ Cracks ☐ Mortar ☐ Roots ☒ **Wall**

Frame leaks. Corbel and Barrel infiltration.

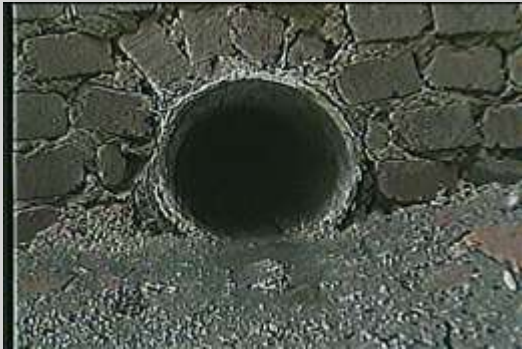
Pipe Out @ 12 O'Clock

Condition: ☐ Sound ☐ Cracked ☐ Root Intrusion ☐ Loose Brick ☒ **Deteriorated**

Infiltration: ☐ None ☐ Joint ☐ Cracks ☒ **Mortar** ☐ Roots ☒ **Wall**

Barrel deterioration and infiltration.
